Case Study
Chambers Hotel
Hennepin Avenue
Minneapolis, Minnesota

Innovative concrete design last century

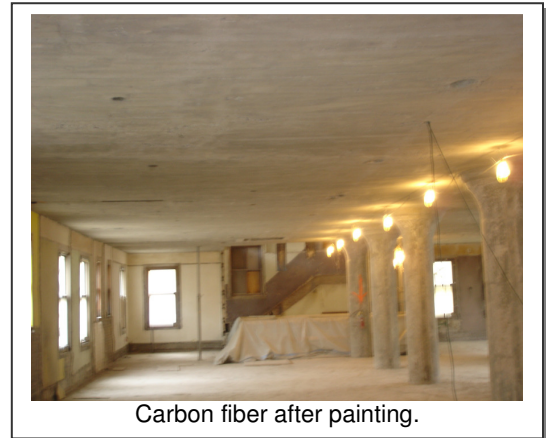
Carbon fiber after painting.

MMY developed a structural package of drawings using innovative carbon-based fiber reinforcing and new reinforced concrete topping to strengthen and stiffen the existing structural slabs on 3 floors while trying to maintain a ceiling height as high as possible. The existing floor to floor heights were short enough that any other structural system could not be used to reinforce the existing slabs. Composite Systems, Inc. used carbon-based Tyfo SCH-41 Composite System to increase the flexural capacity and aid in increasing the 4-way slab stiffness. The previous concrete innovations created a structure that lasted 100 years, the latest innovations we used on the building will hopefully make it last beyond the next 100 years.

The carbon-based Tyfo SCH-41 Composite System that was applied to the bottom of the 4-way slabs was adhered with epoxy compounds in 2 directions while reinforced concrete topping was applied to the top of the rough slabs using bonding agents and small diameter rebar.
